# Apollo2 MCU

## Errata List

**Doc. ID: SE-A2-5p00**

# Silicon Errata for the Apollo2 MCU (AMAPH1KK-xxx)

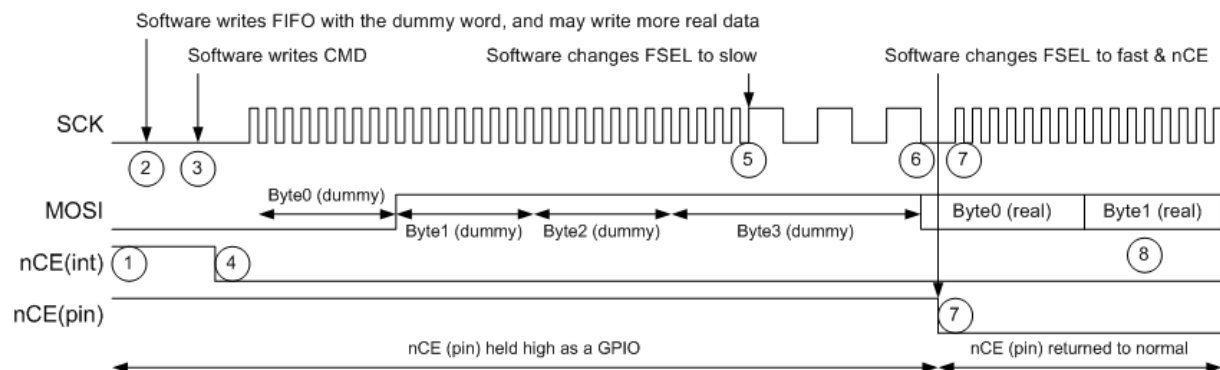
**Figure 1. Software Workaround Write Timing**

This erratum concerns a marginal timing condition in the I2C/SPI Master Module, in particular, IOM4. This condition only occurs on the asynchronous load of the first byte of an IOM4 SPI or I2C transfer. No other byte transfers are affected on IOM4, and no other IOMs exhibit this condition.

This IOM4 timing condition does not occur on every part, and it only occurs on the first byte of a transfer. Bits affected can be different from part to part. If the condition occurs, a bit value of 1 will load as a 0 for the first byte of a master transfer.

Refer to the timing sequence in Figure 1 for references to the occurrence of each of the following steps.

1. The nCE pin is initially configured as a GPIO and held high.
2. The FIFO is loaded with a dummy 32-bit word, which will be ignored by the slave device because nCE will not be asserted when it is transmitted. The dummy word will have all zeros in the first byte, so that the hardware issue, the erroneous load of a bit value of 0 instead of a 1, does not affect it. In the remaining dummy bytes, all bits will be the opposite polarity of the high order bit of the first real transfer byte (the first byte of the 2<sup>nd</sup> 32-bit word written to the FIFO). In this first scenario, the high order bit of Byte0 (real) is a 1, so the dummy bytes are all zero.

3. A write to the CMD register to perform a Raw Write is made, with the desired transfer length + 4 bytes. Interrupts are disabled prior to the CMD write.

4. The internal nCE signal goes low, but the nCE pin is held high as a GPIO.
5. The HAL code waits until the transfer is in the middle of the 4<sup>th</sup> byte. At that point the IOM frequency is divided by the smallest power of 2 which reduces it below 1 MHz. This allows the HAL to reliably change the nCE pin back to normal mode.

6. SW waits until it sees a transition on the MOSI pin, which<sup>(1)</sup> can be observed as a GPIO even in MOSI mode. This indicates that the falling edge of the 32<sup>nd</sup> clock has occurred.

7. When the edge is detected, the nCE pin is switched back to the normal nCE function and the clock frequency is returned to the original requested frequency. Interrupts are enabled at this point.

8. The transfer then proceeds normally to completion.

1. Timing between steps 3 – 5 is regulated by a ROM-based calibrated delay routine and the processing between steps 5 – 6 is hand coded in assembly language. The HAL code has been tested across the Ambiq supported toolchains (Keil, IAR, GCC), however we recommend that optimization be used.

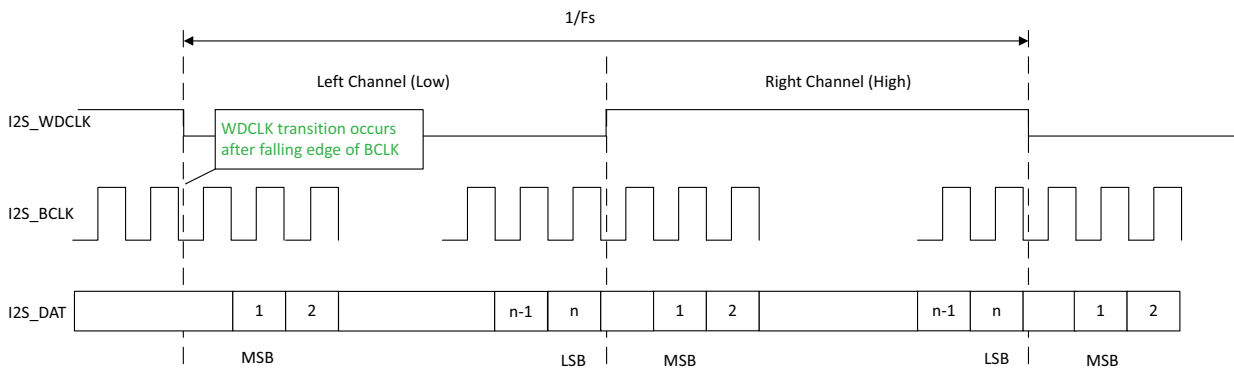
**Figure 4. Valid I2S Timing**

The timing diagram in Figure 4 shows the timing relationship among the BCLK, WDCLK and I2S\_DATA signals as seen and required by the host controller. Here you can see that the I2S\_WDCLK edge transition occurs an adequate time after the falling edge of I2S\_BCLK for it to be sampled and observed.

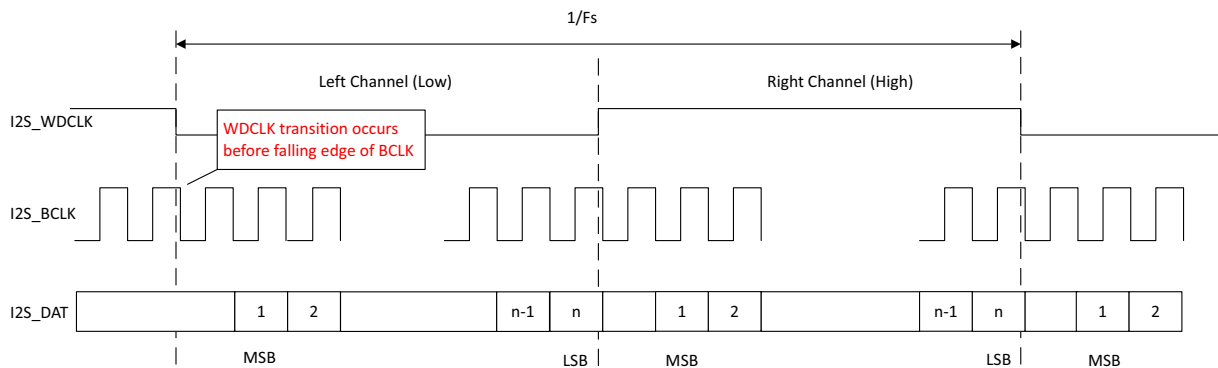
**Figure 5. I2S Timing Due to Propagation Delays on BCLK input**

The issue for this erratum is that WDCLK is sampled on the falling edge of BCLK instead of on the rising edge. At least 4 ns of hold time is required on WDCLK after the falling edge of BCLK, and if WDCLK transitions too close to the falling edge of BCLK, the WDCLK edge is missed completely. Internally, BCLK encounters some propagation delays which cause the WDCLK transition to occur too close to the falling edge of BCLK. The solution is to delay the transitions of WDCLK so they do not occur near the falling edge of BCLK, and the delay can be anything from 4 to 60 ns.

The timing diagram of Figure 5 shows the relative timing of the BCLK and WDCLK at the input of the I2S module internal to the MCU. This shows how propagation delays in the BCLK line causes the transition of WDCLK to occur too close to, or just prior to, a falling (sampling) edge of BCLK. This prevents the slave from seeing the WDCLK transitions and thus results in no transmission of data by the slave.

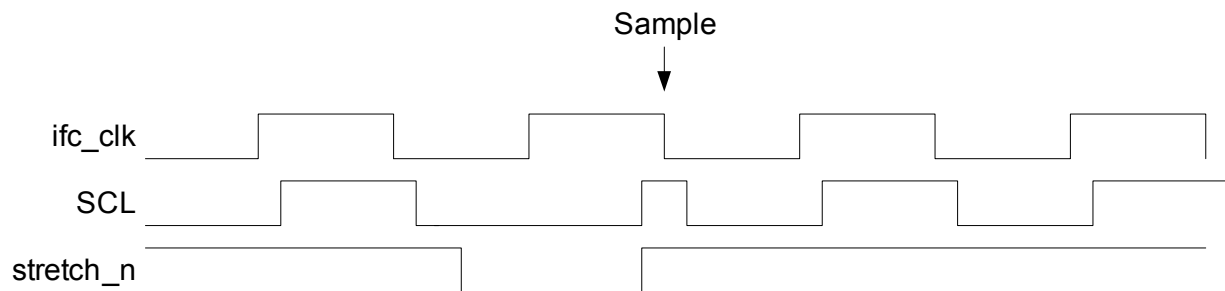
**Figure 7. Shortened High Phase of SCL Due to Unrecognized Clock Stretch by Slave**

The IOM operates on a free-running clock (ifc\_clk) and during normal operation SCL is pulled low during the low period and released during the high period of the clock. A pull-up resistor pulls SCL high, so that normally SCL follows the clock. When the slave device determines on a falling edge of SCL that it needs to stretch the clock, it pulls SCL low with the internal signal stretch\_n. At the rising edge of the clock, the IOM releases SCL but the slave device is holding it low.

The problem occurs because the slave device releases the pull-down of the internal stretch\_n signal before the next falling edge of the clock. Since the IOM has already released SCL, it immediately goes high. However, since the SCL is sampled (as high) on the falling edge of the clock as shown in Figure 7, the stretch is not recognized and SCL is pulled low for the next cycle. This results in a very short high pulse on SCL (a “glitch”) which can corrupt the operation within the slave device.

Note that if the stretch lasts through the next falling edge of the clock, the stretch would be recognized and SCL would not be pulled low at that point. Thus the failure only occurs if three factors are evident, whereby the slave device:

1. Asserts a stretch,
2. Releases the stretch late enough in a cycle so as to produce a short SCL pulse, and
3. Fails when it sees the short SCL pulse.

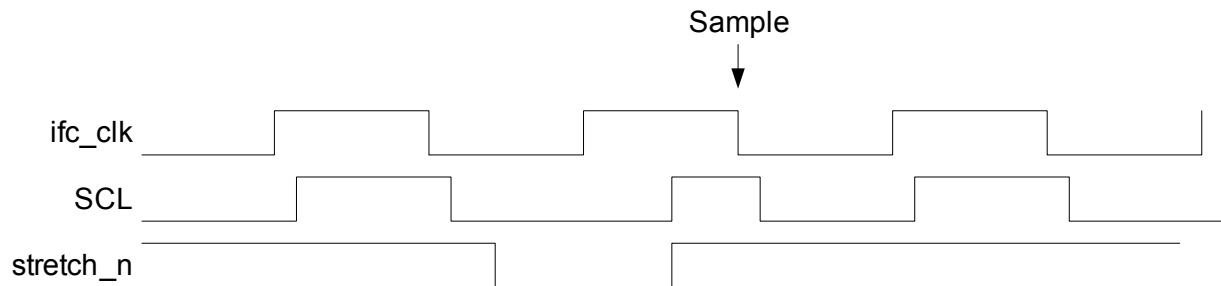
**Figure 9. Occurrence of Sample with a Slower Clock**

The challenge with this approach is that if the stretch time is longer than 2.4  $\mu$ s, the glitch would be shorter and could still fail.

The second solution is to run the clock slower so that the short SCL pulse will still be long enough, as shown in Figure 9 below. The minimum required high time for the SCL in Fast Mode is 600 ns, so if the stretch time is 2.4  $\mu$ s the clock frequency would have to be  $1/(3.0 \mu\text{s}) = 333 \text{ kHz}$ .
