## ERRATA LIST

# Apollo2 System on Chip

Ultra-Low Power Apollo2 (AMAPH1KK-xxx) SoC Family  
A-SOCAP2-ELGA01EN v7.0

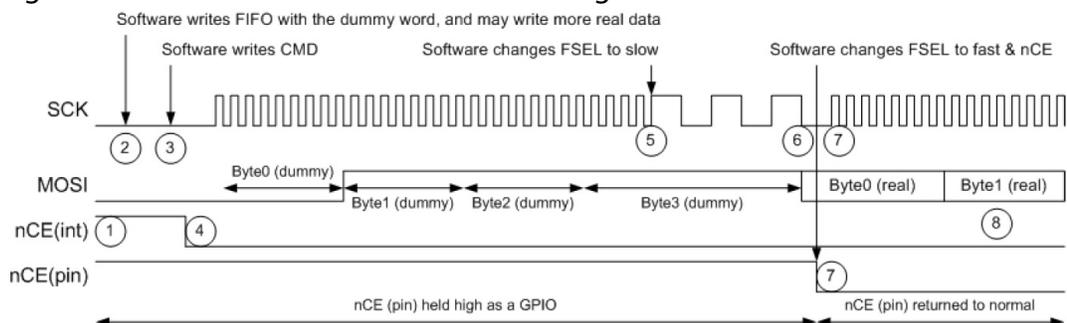
Figure 3-1: Software Workaround Write Timing

Refer to the timing sequence in Figure 3-1 for references to the occurrence of each of the following steps.

1. The nCE pin is initially configured as a GPIO and held high.
2. The FIFO is loaded with a dummy 32-bit word, which will be ignored by the slave device because nCE will not be asserted when it is transmitted. The dummy word will have all zeros in the first byte, so that the hardware issue, the erroneous load of a bit value of 0 instead of a 1, does not affect it. In the remaining dummy bytes, all bits will be the opposite polarity of the high order bit of the first real transfer byte (the first byte of the 2nd 32-bit word written to the FIFO). In this first scenario, the high order bit of Byte0 (real) is a 1, so the dummy bytes are all zero.

3. A write to the CMD register to perform a Raw Write is made, with the desired transfer length + 4 bytes. Interrupts are disabled prior to the CMD write.

4. The internal nCE signal goes low, but the nCE pin is held high as a GPIO.
5. The HAL code waits until the transfer is in the middle of the 4th byte. At that point the IOM frequency is divided by the smallest power of 2 which reduces it below 1 MHz. This allows the HAL to reliably change the nCE pin back to normal mode.

6. SW waits until it sees a transition on the MOSI pin, which<sup>1</sup> can be observed as a GPIO even in MOSI mode. This indicates that the falling edge of the 32nd clock has occurred.

7. When the edge is detected, the nCE pin is switched back to the normal nCE function and the clock frequency is returned to the original requested frequency. Interrupts are enabled at this point.

8. The transfer then proceeds normally to completion.

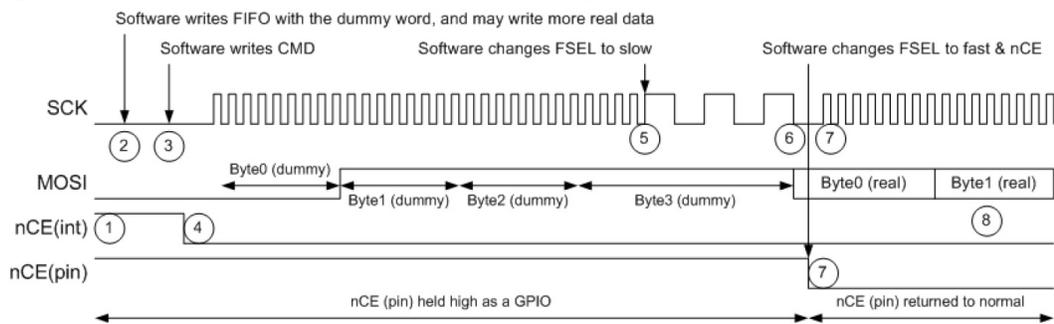
Figure 3-2: Software Workaround Write Timing - Alternate First-byte Scenario

The scenario in Figure 3-2 below presents the alternate case from the above (see step 2) where the high order bit of Byte0 (real) is a zero. In this case Byte0 (dummy) is all zeros, but the other dummy bytes are all ones. This produces an edge on MOSI at the same point (6) as the above scenario.

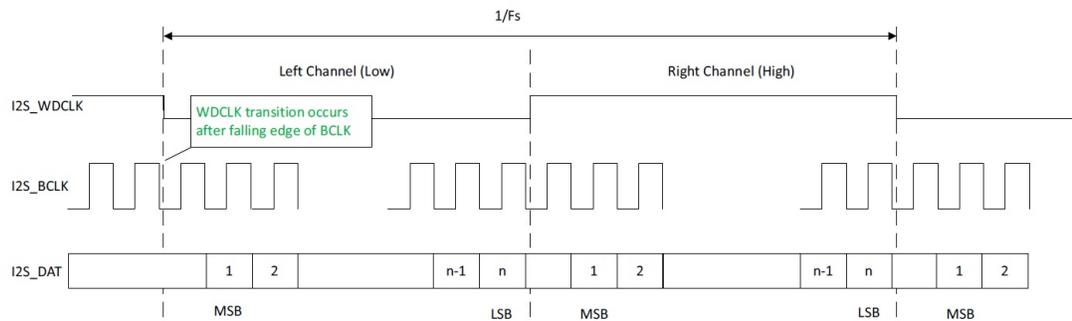
Figure 3-4: Valid I<sup>2</sup>S Timing

The timing diagram in Figure 3-4 shows the timing relationship among the BCLK, WDCLK and I<sup>2</sup>S\_DATA signals as seen and required by the host controller. Here you can see that the I<sup>2</sup>S\_WDCLK edge transition occurs an adequate time after the falling edge of I<sup>2</sup>S\_BCLK for it to be sampled and observed.

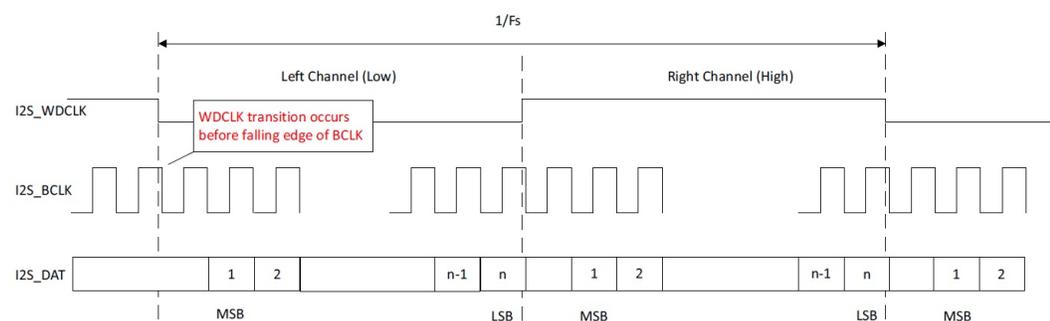
Figure 3-5: I<sup>2</sup>S Timing Due to Propagation Delays on BCLK input

The issue for this erratum is that WDCLK is sampled on the falling edge of BCLK instead of on the rising edge. At least 4 ns of hold time is required on WDCLK after the falling edge of BCLK, and if WDCLK transitions too close to the falling edge of BCLK, the WDCLK edge is missed completely. Internally, BCLK encounters some propagation delays which cause the WDCLK transition to occur too close to the falling edge of BCLK. The solution is to delay the transitions of WDCLK so they do not occur near the falling edge of BCLK, and the delay can be anything from 4 to 60 ns.

The timing diagram of Figure 3-5 shows the relative timing of the BCLK and WDCLK at the input of the I<sup>2</sup>S module internal to the SoC. This shows how propagation delays in the BCLK line causes the transition of WDCLK to occur too close to, or just prior to, a falling (sampling) edge of BCLK. This prevents the slave from seeing the WDCLK transitions and thus results in no transmission of data by the slave.

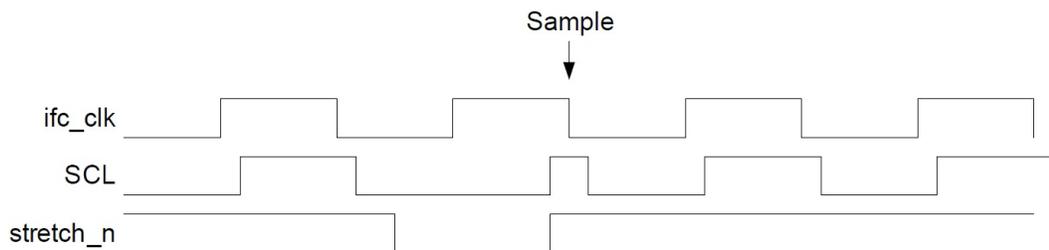
Figure 3-7: Shortened High Phase of SCL Due to Unrecognized Clock Stretch by Slave

The problem occurs because the slave device releases the pull-down of the internal stretch\_n signal before the next falling edge of the clock. Since the IOM has already released SCL, it immediately goes high. However, since the SCL is sampled (as high) on the falling edge of the clock as shown in Figure 3-7, the stretch is not recognized and SCL is pulled low for the next cycle. This results in a very short high pulse on SCL (a “glitch”) which can corrupt the operation within the slave device.

Note that if the stretch lasts through the next falling edge of the clock, the stretch would be recognized and SCL would not be pulled low at that point. Thus the failure only occurs if three factors are evident, whereby the slave device:

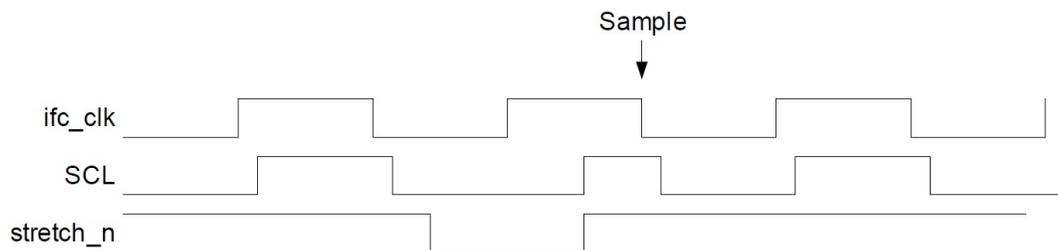
Figure 3-9: Occurrence of Sample with a Slower Clock

The challenge with this approach is that if the stretch time is longer than 2.4  $\mu$ s, the glitch would be shorter and could still fail.

The second solution is to run the clock slower so that the short SCL pulse will still be long enough, as shown in Figure 3-9 on page 30 below. The minimum required high time for the SCL in Fast Mode is 600 ns, so if the stretch time is 2.4  $\mu$ s the clock frequency would have to be  $1/(3.0 \mu\text{s}) = 333 \text{ kHz}$ .
