ERRATA LIST

Apollo3 Blue SoC

Doc. ID: SE-A3-4p3

Doc. Revision: 4.3, September 2022

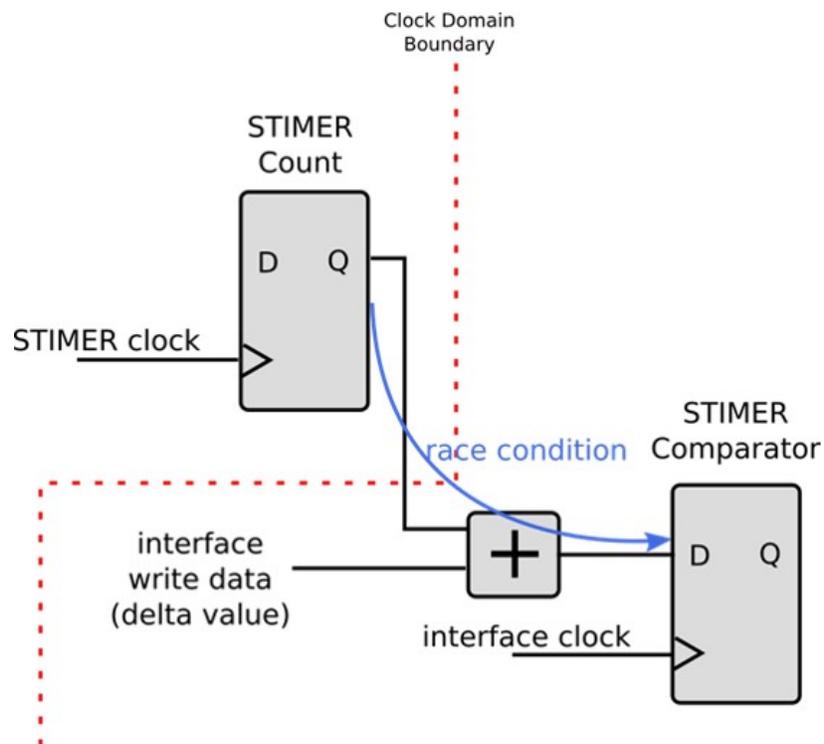
Figure 1. STIMER Compare Register Update Race Condition

The STIMER compare register may capture invalid data as the add operation is in the process of computing the new value. Thus there is a race condition between the STIMER clock and the interface clock.
