# HUAWEI Remote Control Cannot Recognize Voice Instruction Issue Periodic Report

October 2023

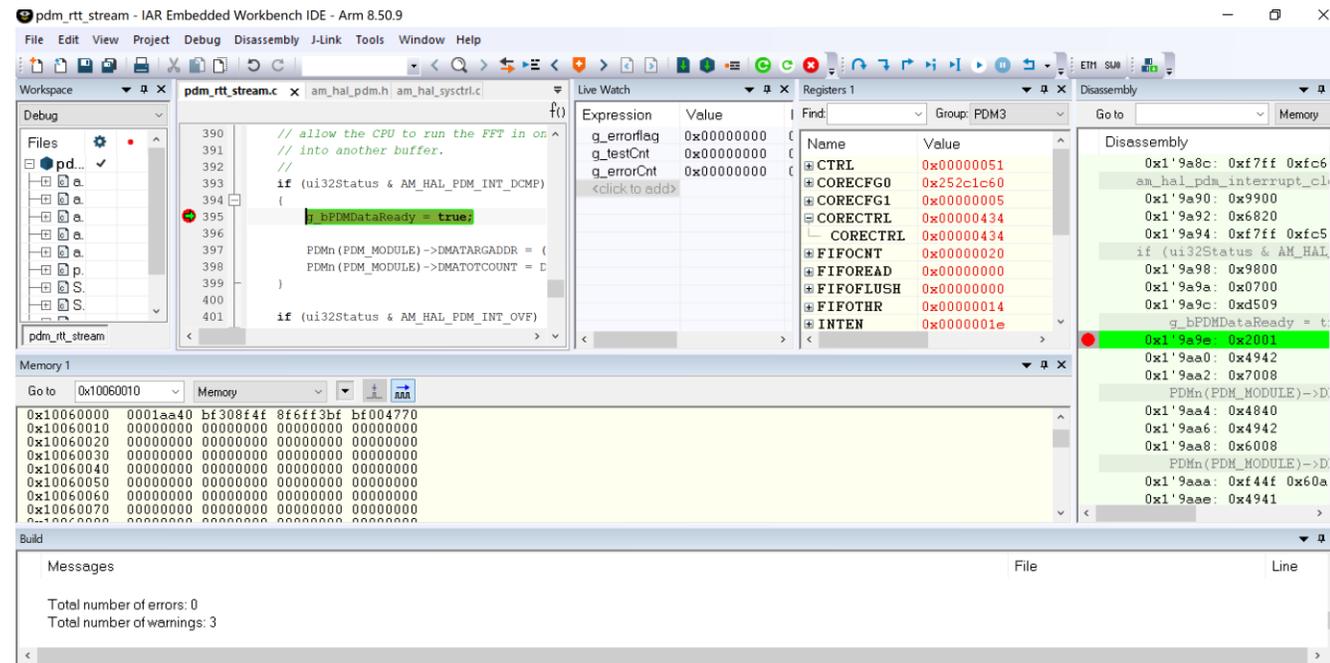
- **Affected Device:**
  - Apollo4 Blue (AMA4B2KK-KBR-B2)
- **Description:**
  - After switching to button mode, some of the controller shows the issue phenomenon that voice instruction cannot be recognized by SmartTV, it may be recovered soon.
  - We use IAR attach to check the PDM DMA buffer once PDM DCMP interrupt comes, and at this time, it shows invalid data with all '0' in the buffer.

**Note:**  
PDM buffer all '0' when issue reproduced.

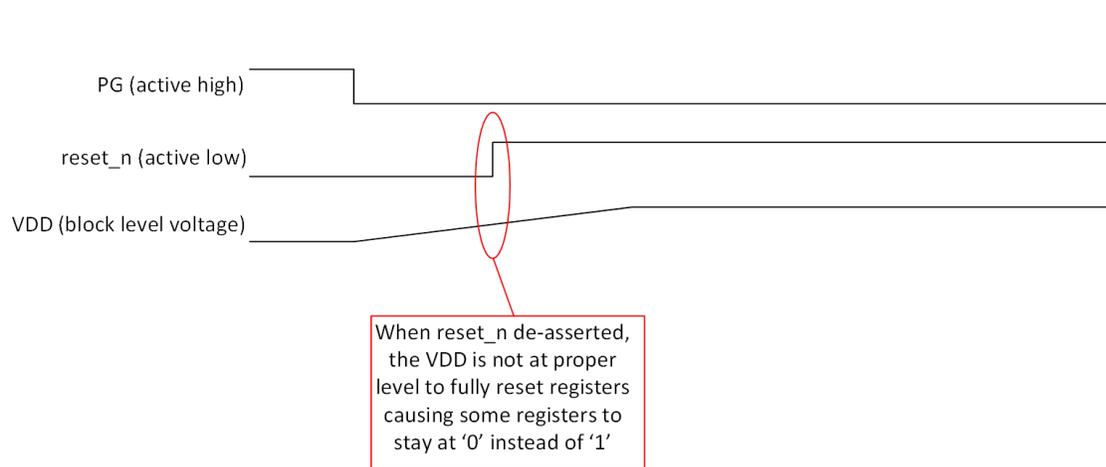
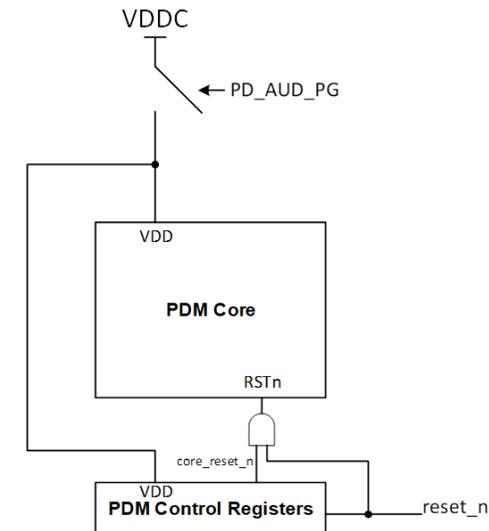
- PD\_AUD\_PG 0 means the control to the power switch is turned on
- We have evidence to suggest that the delay to fully ramp the voltage domain of the PDM block after PG de-assertion is longer than the delay from PG to reset\_n de-assertion.
- As such, reset could be de-asserted **before the PDM power rail is fully ramped up**, so those FF (Flip-Flop) that are **resetted to high but cannot go high**
- During issue case registers check, all belongs to expect 1 but as 0, which aligns the analysis result here.
- This only affects the configuration registers since, as part of the init sequence, we have a separate reset to the PDM core logic which ensures the core registers are properly initialized. See diagram lower right corner.

- After PDM power on, in the case of a non-default register value, write the registers to their default value.
- We already verified it on the multiple known issue boards (#1, #3, and #4), all without issue anymore.
- This change will be included in Ambiq's later SDK release.
- Patch file already provided to Huawei software for integration.

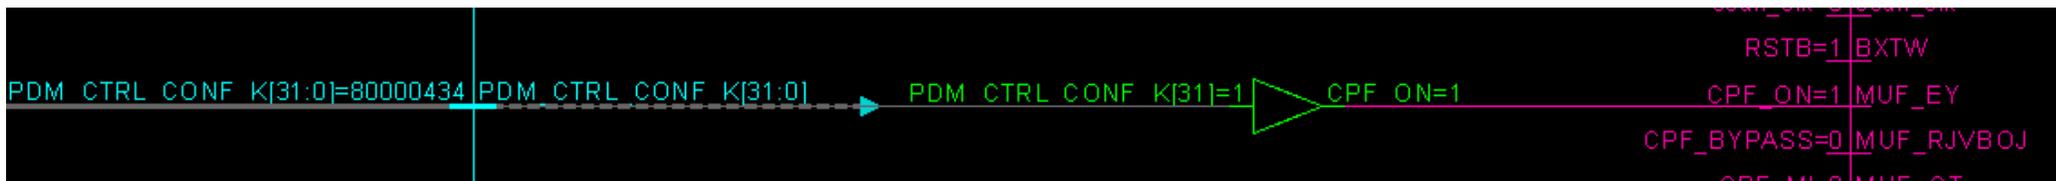
\* PDM.CORECTRL reg(0x4020400C) is unexpectedly cleared

- CORECTRL[31] is the enable signal for internal filter, if it was disabled (0), output data will be zero

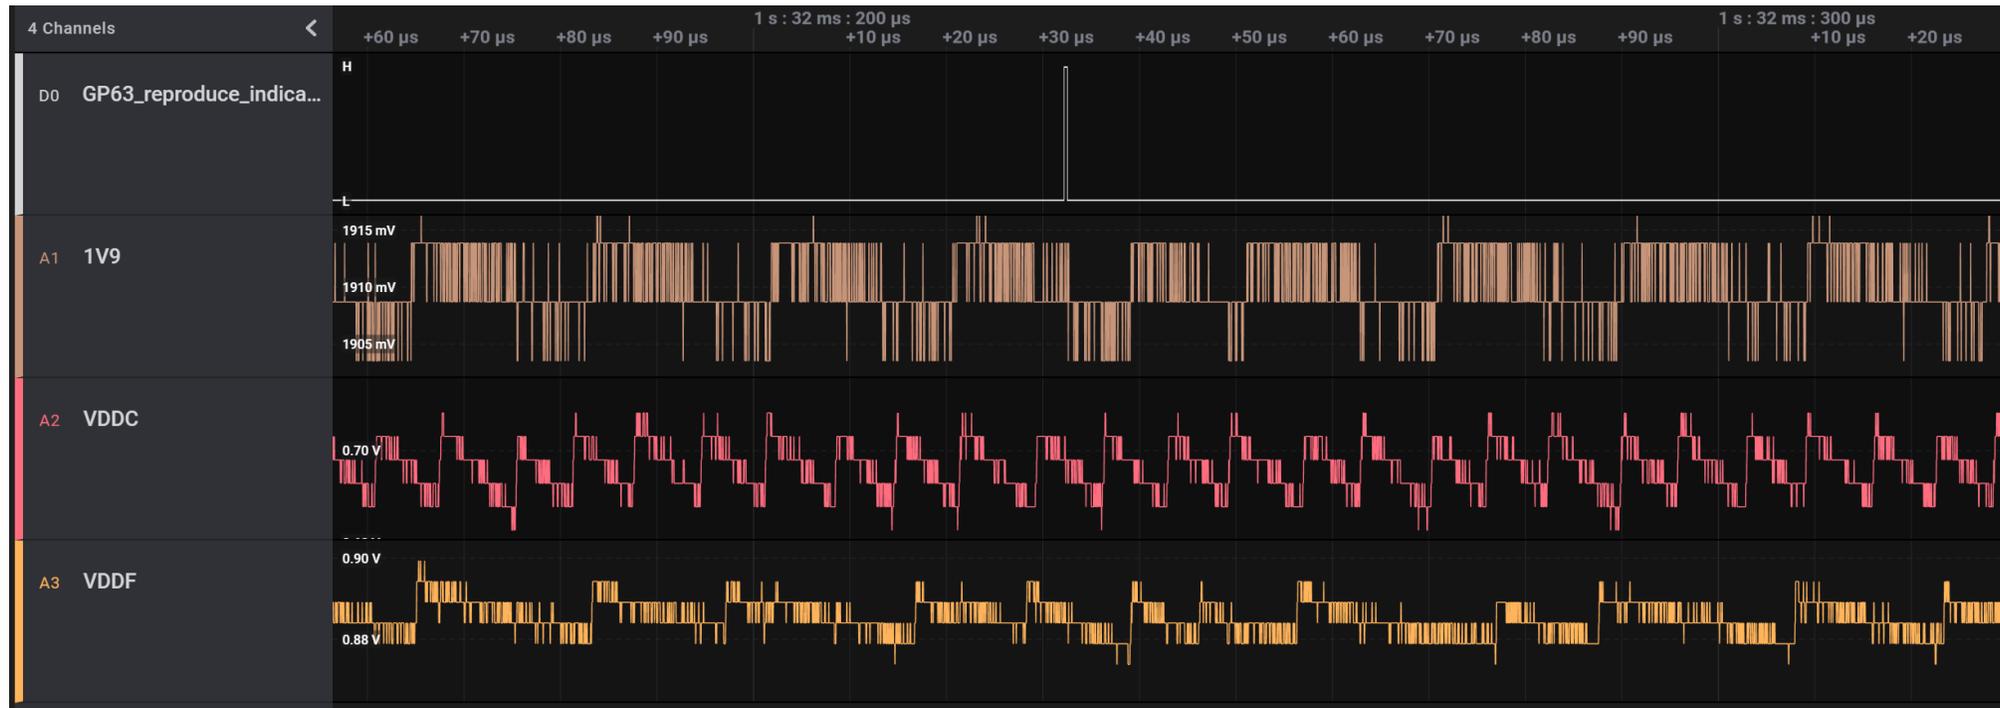
- We measured the power rail (1V9/VDDC/VDDF) when issue occurred, GPIO63 is used to indicate when the issue reproduced.
- Seems nothing abnormal here.

- If HFADJ/HFADJ2 disabled, bit31 is also cleared when issue occurred.
